Results of H2020 STORM project in the assessment of damage to cultural heritage buildings following seismic events

Abstract— *The Corpo Nazionale dei Vigili del fuoco Italian (Italian Fire and Rescue Services) provides the emergency verification of the static safety of buildings in urgent technical assistance and calamities. This activity also concerns cultural heritage and was the subject of a research and development project funded by the European Commission in the Horizon 2020 program. This project (STORM) made it possible to verify, with a positive outcome, the possibility of using Lidar technologies to support safety assessments in emergency conditions.*

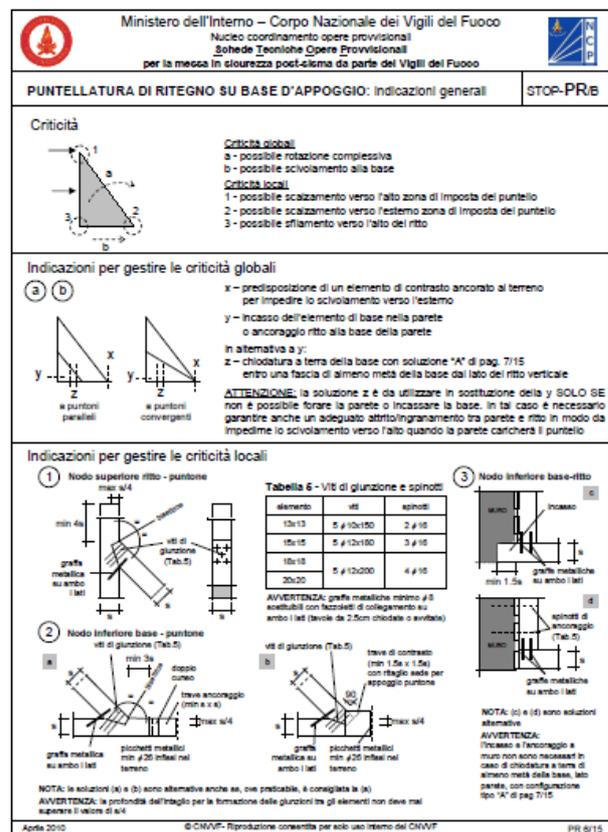
Fig. 1 - Example of provisional technical data sheet of the "Vademecum STOP".

The use of the STOP cards was accompanied, more generally, by the adoption of an engineering approach - survey, design, logistical-operational organisation of the intervention, execution, documentation and reporting – which allowed increasing levels of complexity on large structures that would have been unthinkable even a few years earlier [8] (for example, the Church of the Blessed Souls AQ-2009, Church of Saint Giusta AQ-2009, Church of San Silvestro AQ-2009, Church of Saint Mary ‘Paganica’ AQ-2009, Basilica of Saint Benedict PG-2016 and the Tower of Accumoli RI-2016). The use of these cards, as discussed later in the document, would be improved in the hypothesis of designing the structures starting from precision measurements acquired at a distance, thus limiting the risk exposure of the personnel assigned to perform the reliefs. Furthermore, this work would be easier to be formed, as it is free from uncertainties in the choice of structural solutions and construction materials.

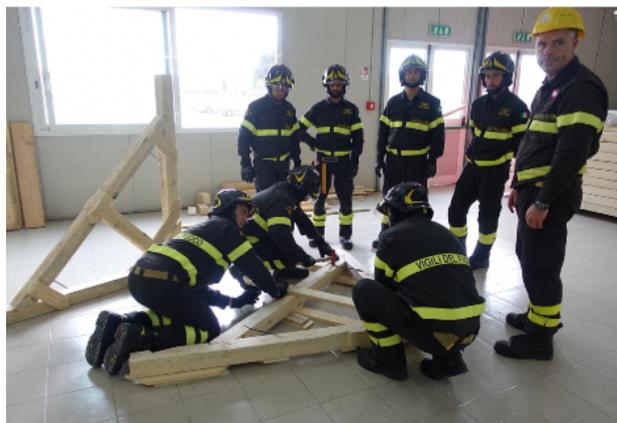
Fig. 2 - CNVVF training module relating to the construction of temporary works - Scuole Centrali Antincendio (CNVVF).

The training module consists of 36 hours of training divided between a theoretical and a practical part, in which the techniques for creating the shoring structures are applied from their design to the realisation of the individual elements (Fig. 2).

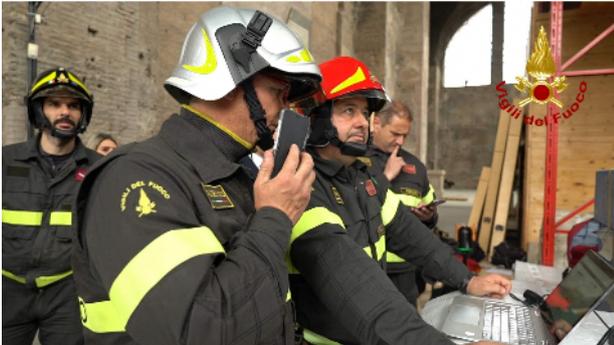
Fig. 3 - STORM project. Final exercise of 13 May 2019 at the pilot site of the Museum of the Baths of Diocletian on the use of the laser scanner for emergency relief and an integrated platform for the design of temporary works (image: CNVVF).

To achieve this objective, the CNVVF defined the information needs of the platform to support emergency management and deepened the knowledge on the tools available on the market, carrying out tests in the operational scenarios of the earthquake of 24 August 2016 in Norcia. In a nutshell, the hypothesis developed in the project is characterised by an increasing CNVVF operational capacity in safety assessments through the use of Lidar systems and the comparison of scans acquired in an emergency with those previously carried out by the manager of the buildings. The latter should be made available on the platform through a cloud system accessible in an emergency (Fig. 4). This scenario was successfully verified during the test organized at the Terme di Diocleziano Museum on May 13, 2019.

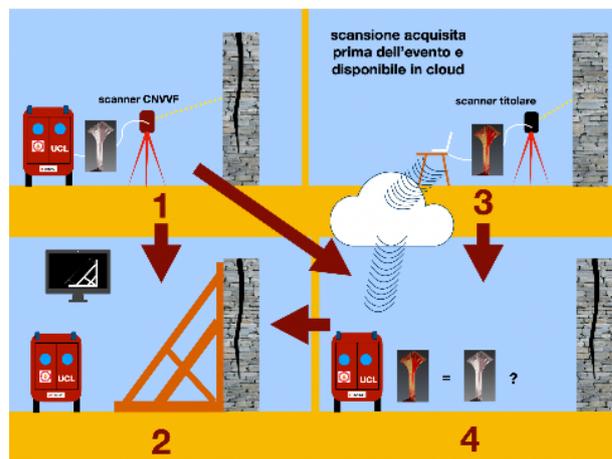
Fig. 4: Operating hypothesis developed in the STORM project relating to the use of the laser scanner to support the assessment of the stability of buildings. The general hypothesis (1) provides for the CNVVF to intervene and use the survey carried out on the scenario for risk assessment and the design of the provisional structure (2). In the event that a scan of the building acquired in ordinary conditions is available in the cloud (3), the CNVVF could compare it (4) with that scan acquired on the scenario (1) for a more precise risk assessment and the design of the provisional structure (2).

Applied in a large-scale emergency, the project would allow the CNVVF to compare the scans acquired on the spot with those made before the incidental event, to assess the differential

displacements suffered by significant points from the structures (displacements acquired in the order of the size of millimetres, or in the worst conditions, of centimetres). This hypothesis, already feasible as the technologies are validated and available on the market at affordable costs, presupposes an agreement between the interested parties to define the acquisition and exchange standards of the 3D point clouds, including the documentation necessary to determine the accuracy of 3D images.
